**HAZARDOUS MATERIALS SURVEY  
FORMER TINLEY PARK MENTAL HEALTH FACILITY  
TINLEY PARK, ILLINOIS**

A multi-media site inspection was conducted at the former Tinley Park Mental Health Center (TPMHC) on December 17 and 18, 2019 following receipt of a complaint. The site is an abandoned mental health facility that is currently owned by the Illinois Department of Central Management Services (CMS). The inspection was conducted pursuant to a special request from Springfield following a citizen's complaint. Several environmental areas of concern were observed and noted by the Agency's inspectors.

Site: Tinley Park Mental Health  
Ctr (0314915027)  
Cook County

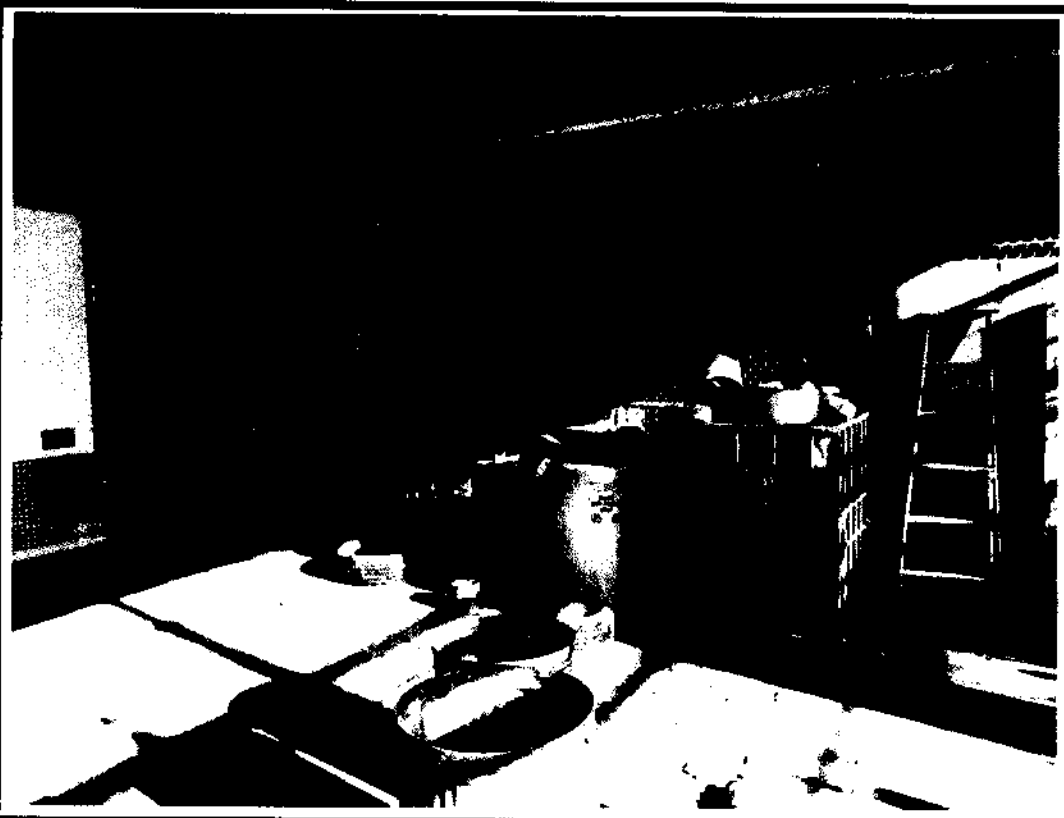
Photo ID: 12  
Photo Date: 12/17/2019  
Photo Time: 10:31:35  
Direction: E  
Taken By: Thomas Rivera

Inside Transportation  
Building/Garage (Maintenance  
Building)

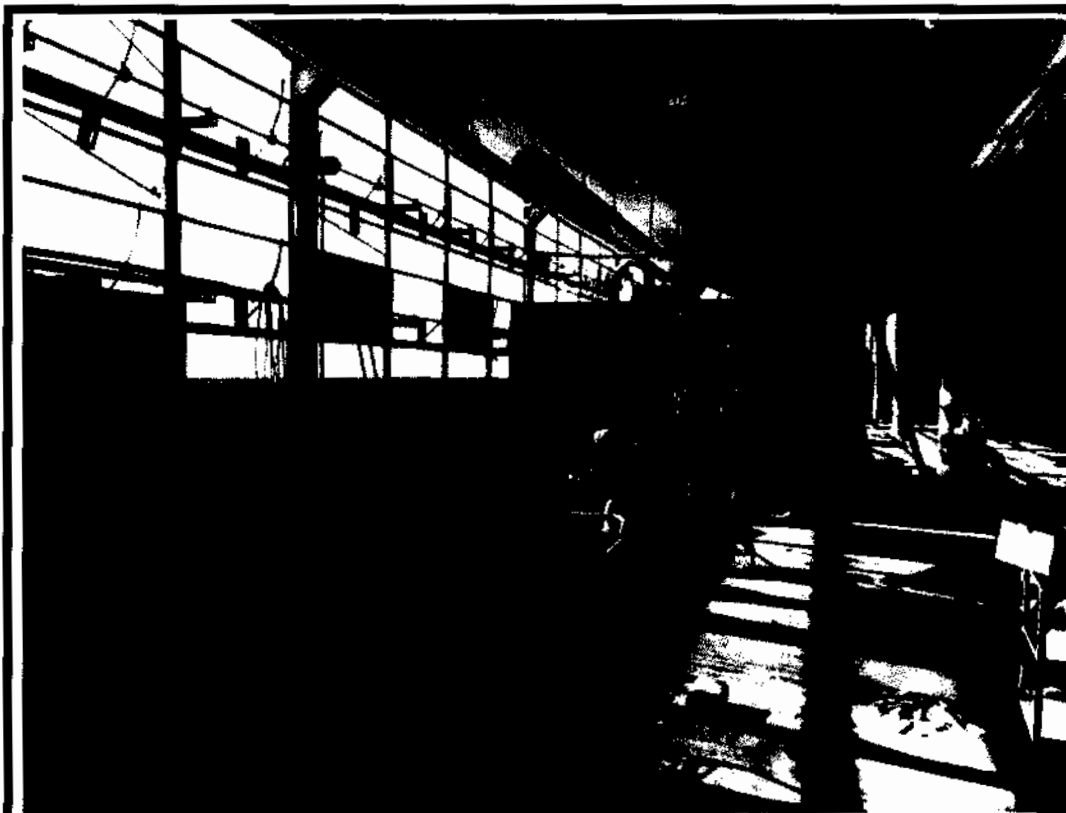
Photo ID: 13  
Photo Date: 12/17/2019  
Photo Time: 10:33:54  
Direction: W  
Taken By: Thomas Rivera

Plastic drum of anti-freeze and  
tote containing oil inside  
Transportation Building/Garage  
(Maintenance Building)

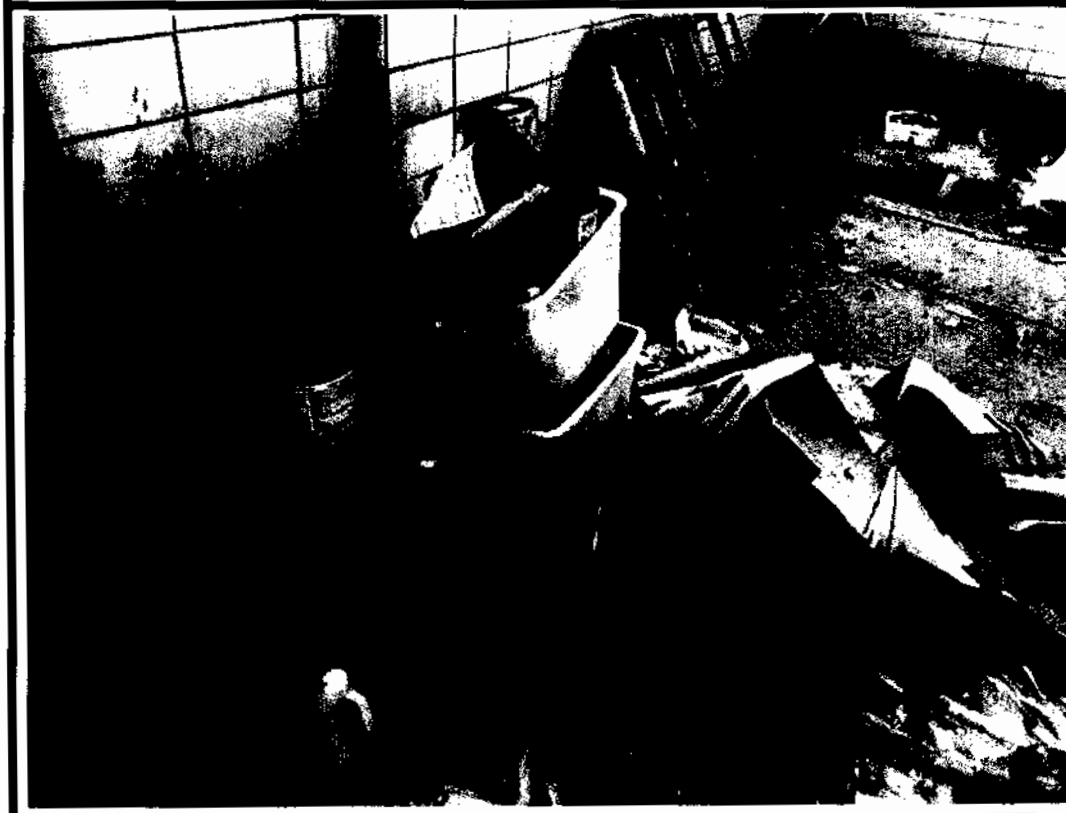
Photo ID: 14  
Photo Date: 12/17/2019  
Photo Time: 10:37:30  
Direction: W  
Taken By: Thomas Rivera

Scrap tires on the floor inside  
Transportation Building/Garage  
(Maintenance Building)

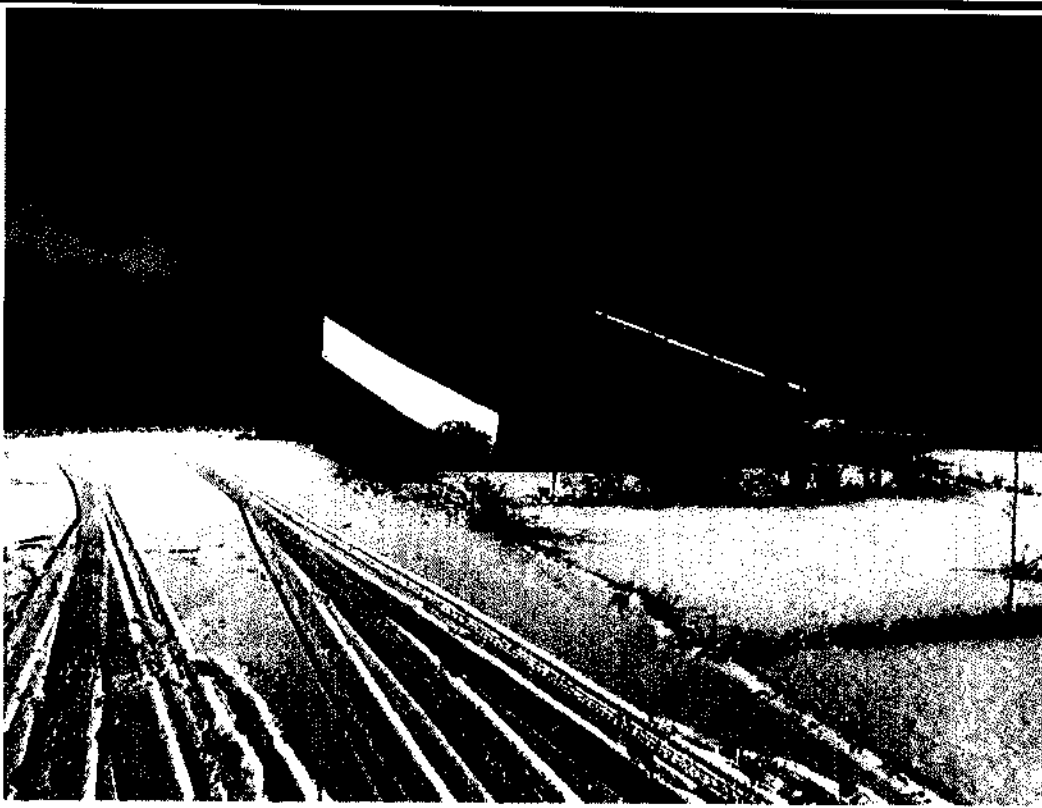
Photo ID: 20  
Photo Date: 12/17/2019  
Photo Time: 11:15:32  
Direction: W  
Taken By: Thomas Rivera

Two "active" USTs are located outside the Transportation Building/Garage (Maintenance Building). Both tanks have a 10,000-gallon capacity. One tank was used to store gasoline and one was used to store diesel fuel. Both tanks were used to supply the on-site fueling station. (See photo 19). According to Mr. Capello, both USTs are empty. The canopy from the fueling station was observed in a collapsed state, resulting from a past wind storm. (See photo 20).

Canopy blown upside down  
near the former on-site fueling  
station
